LASH SHIP PRETEST RESULTS OF THE JOINT
LOGISTICS-OVER-THE-SHORE (LOTS) TEST (U) OPERATIONS
RESEARCH INC SILVER SPRING MD H CASEY ET AL. 07 MAR 77

ORI-TR-1121 MDA903-75-C-0016

Rept. No. ORI-TR-1121

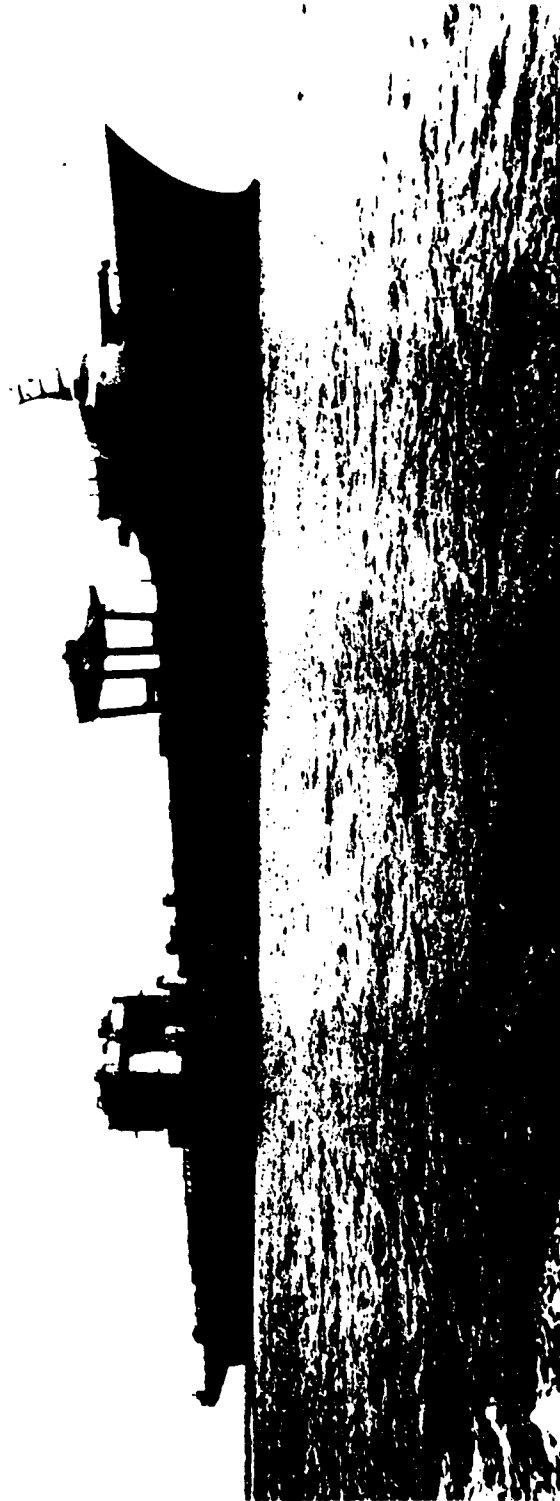
FIGURE 1. S.S. LASH ITALIA. The S.S. LASH ITALIA, a C881 Lighter-Aboard-Ship vessel, was chartered August 23-26, 1976, for the second in a series of LOTS pretests (the first pretest involved a conventional breakbulk ship). The LOTS pretest provided the Services the first opportunity to dedicate a LASH ship solely for military logistic operations and to operationally test the LCM8 lift beam.

The considerable lift capability of the LASH ship barge crane (approximately 500 short tons), the large clear area available for on-deck stowage, and spacious holds below make the LASH vessel especially attractive for deploying heavy, outsized equipment. (See Figure 1.) With 20 LASH vessels in service, the total lift potential in support of military operations is considerable.

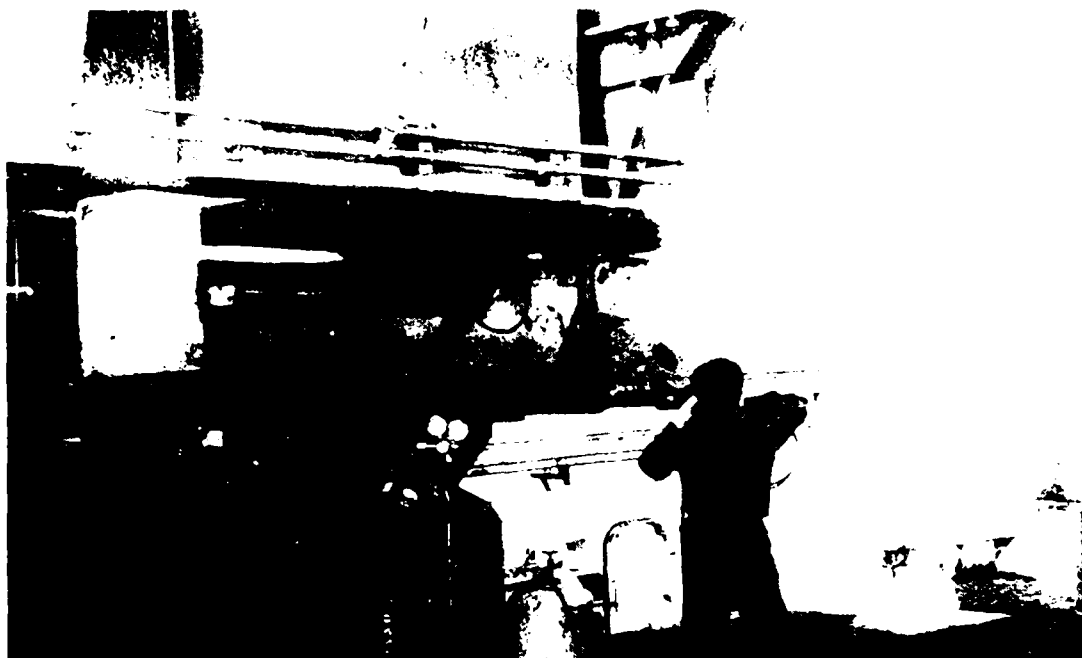
FIGURES 4 and 5. LCM8 LIFT BEAM IS ENGAGED. Following modification of the gathering cones with a cutting torch (above), the first LCM8 lift beam was engaged (lower photo) within 15 minutes, the second beam required 30 minutes. The requirement for modifying the lifting cones on an Alliance type crane (used on 14 of the 20 LASH vessels) was a major revelation from the LOTS pretest.

An inside lip on each of the gathering cones (see Figures 4 and 5) prevented the cone from settling down far enough over the beam's lifting points for a horizontal locking bar to be engaged. The bar must pass through the load frame's gathering cone, through a hole in the LCM8 beam lifting point, and through the gathering cone on the other side in order to be fully engaged. As long as the lip prevented the proper seating, the locking mechanism was obstructed.

owners. The four inside lips were trimmed off (Figures 4 and 5) and approximately 45 minutes later both LCM8 lifting beams were engaged.

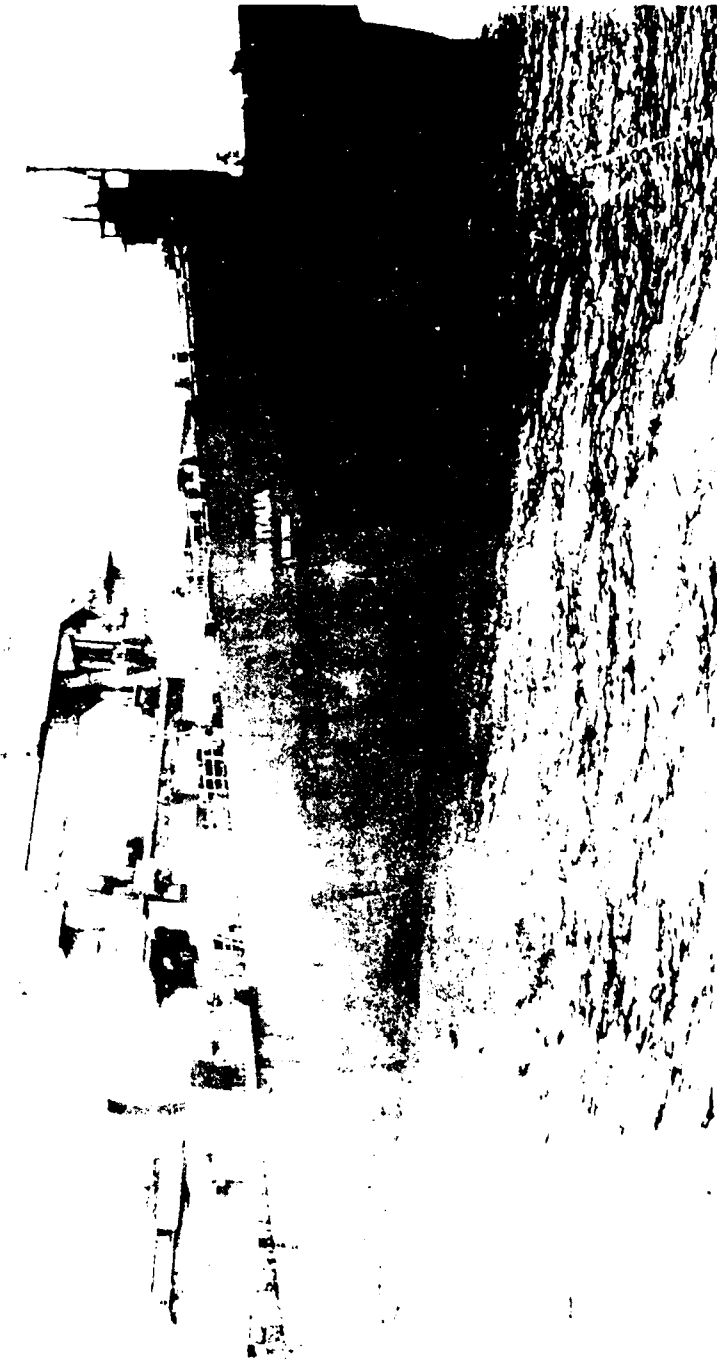
U.S. LASH ITALIA AT ANCHOR. The LASH Italia, chartered August 24-25, 1964, was the first ship to be solely dedicated to a military exercise. LASH Italia embarked in port and disembarked at anchor, large LOTS equipment items using only 100 tons. LASH Italia also operationally tested the new LOTS program. The LASH ship pretest was the second in a series conducted under the Joint LOTS Test and Evaluation program.

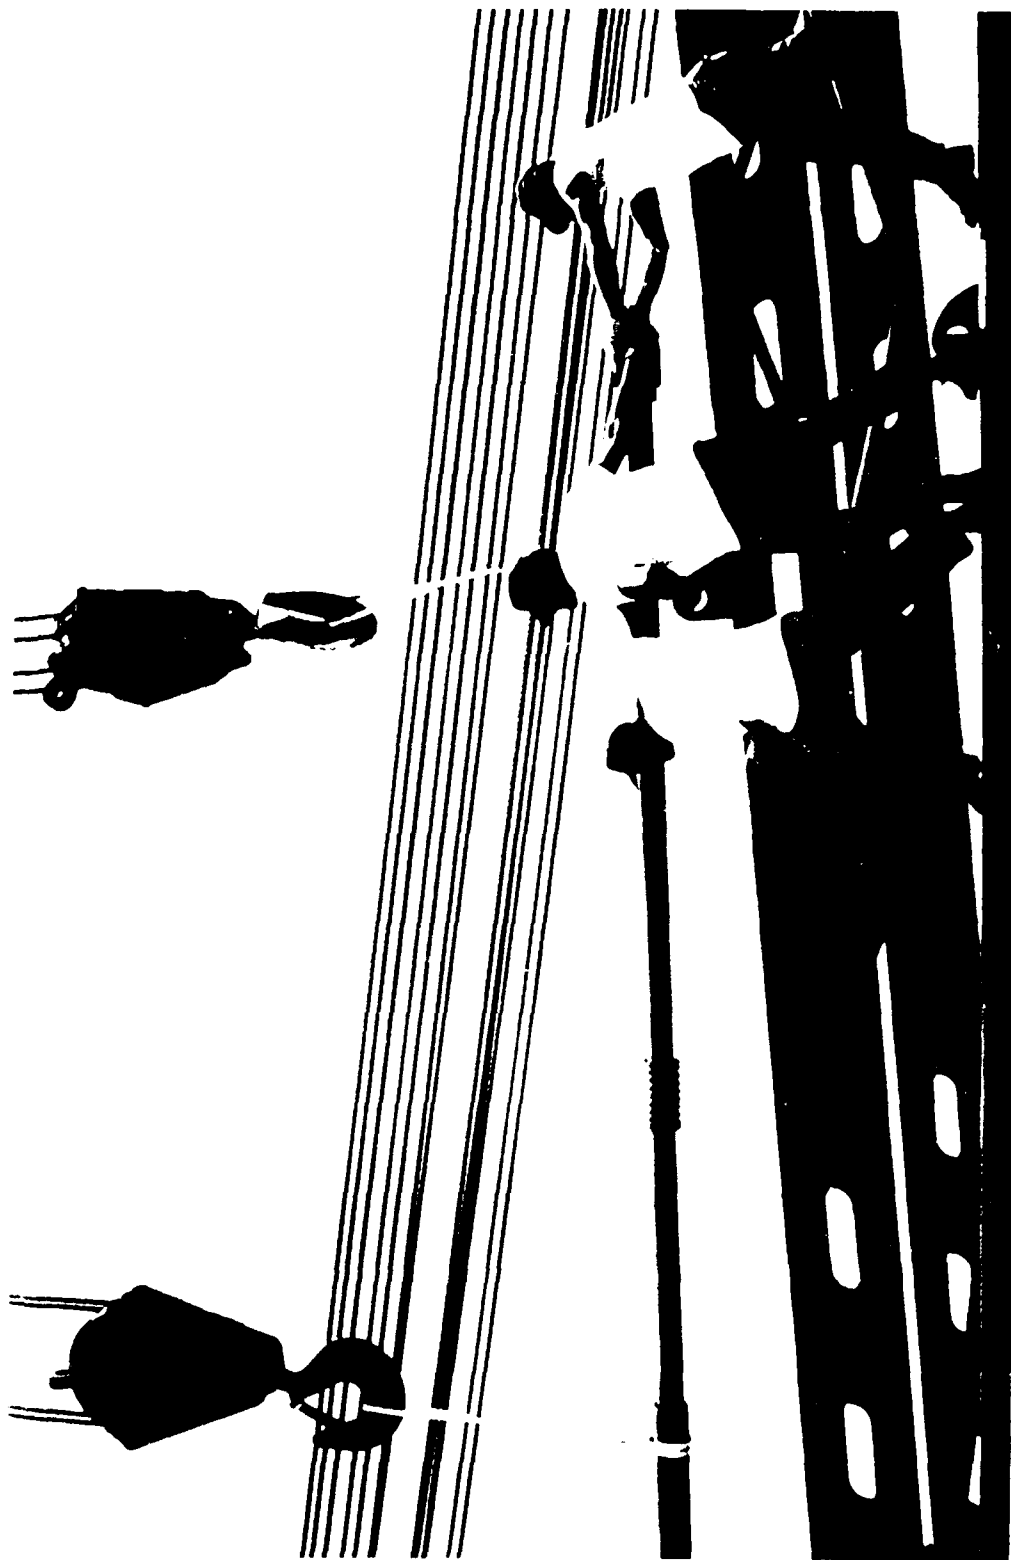
E.2 CRANE DISASSEMBLY. In order to evaluate deployment feasibility of the 30-ton crane, the Army's 6250 crane was one of the priority items to be loaded. Because the crane had to be lifted to a space in the objective area by a landing craft (an LVT), also embarked in the LST, it was necessary to disassemble the crane into its administrative configuration.

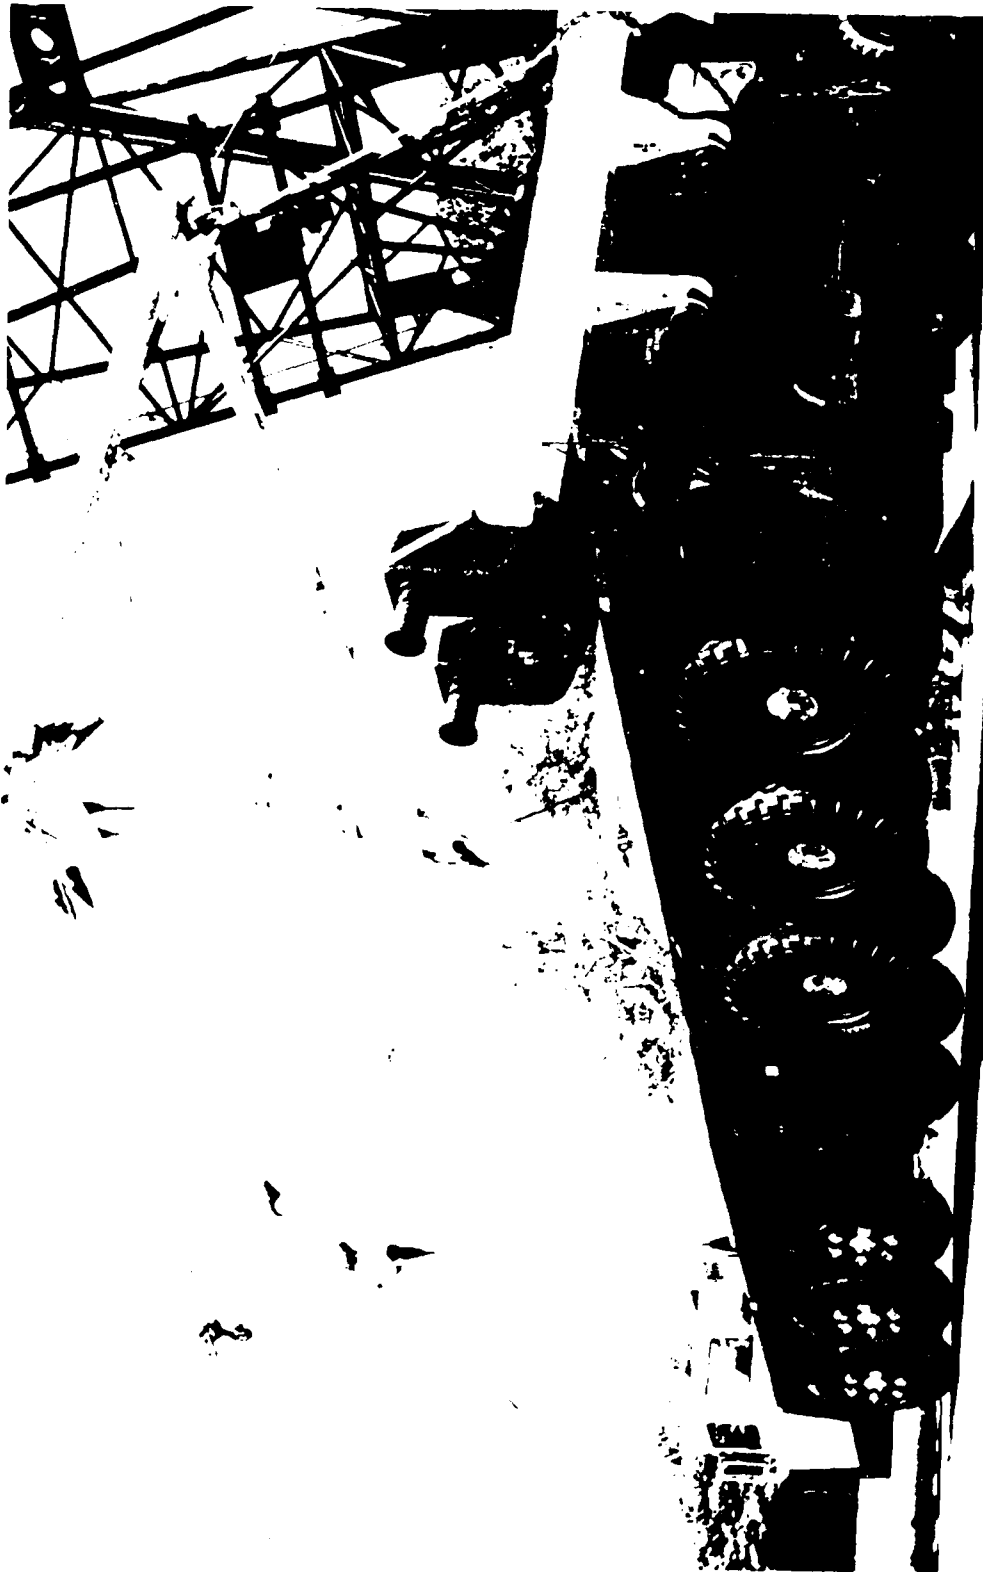
E.3. NEW SLING TESTED. Prior to the LOTS pretest it was necessary to check-test a new stronaback for lifting the container cranes. Above, the carrier for the Army's 300-ton capacity crane is hoisted by the Army's 150-ton container crane. The crane jibber, although heavier, is shorter—ever when mobile-loaded on an W47 trailer—and relatively easy to off-load into a tank. Therefore, the crane carrier was not part of the protocol.

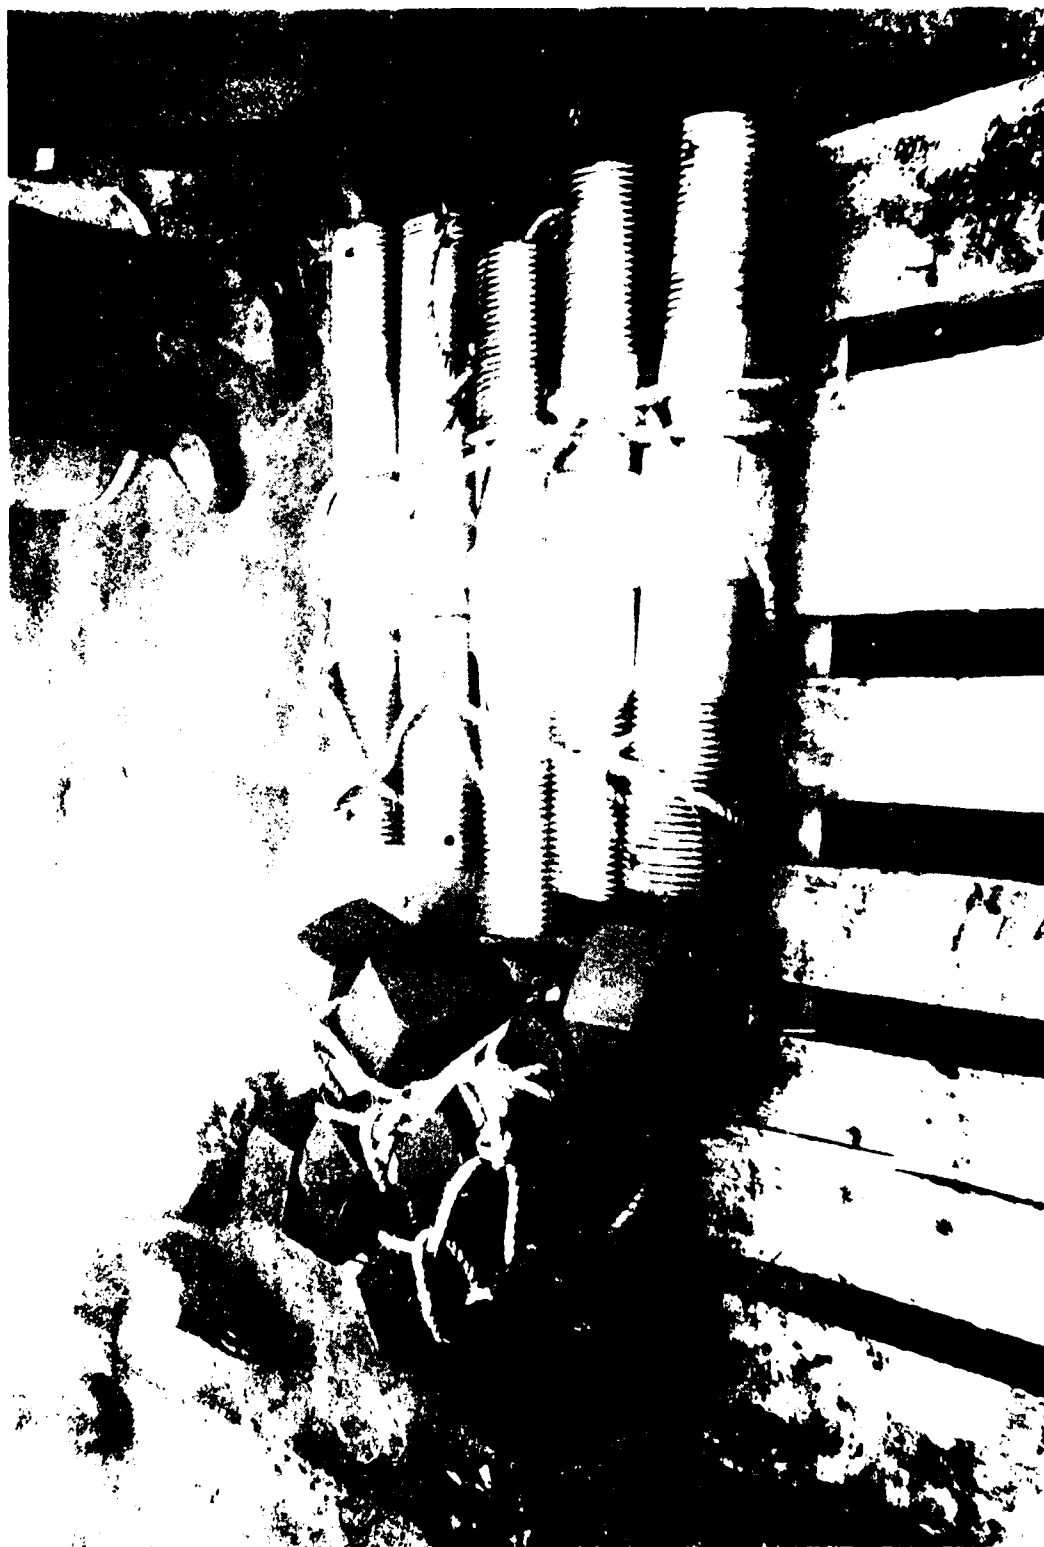
E.5. SPECIAL DISGRIFF APP USED. Because of the exceptionally heavy test equipment to be loaded, very large pins and nuts were required for attaching shackles and chains to the LCM lift bars.

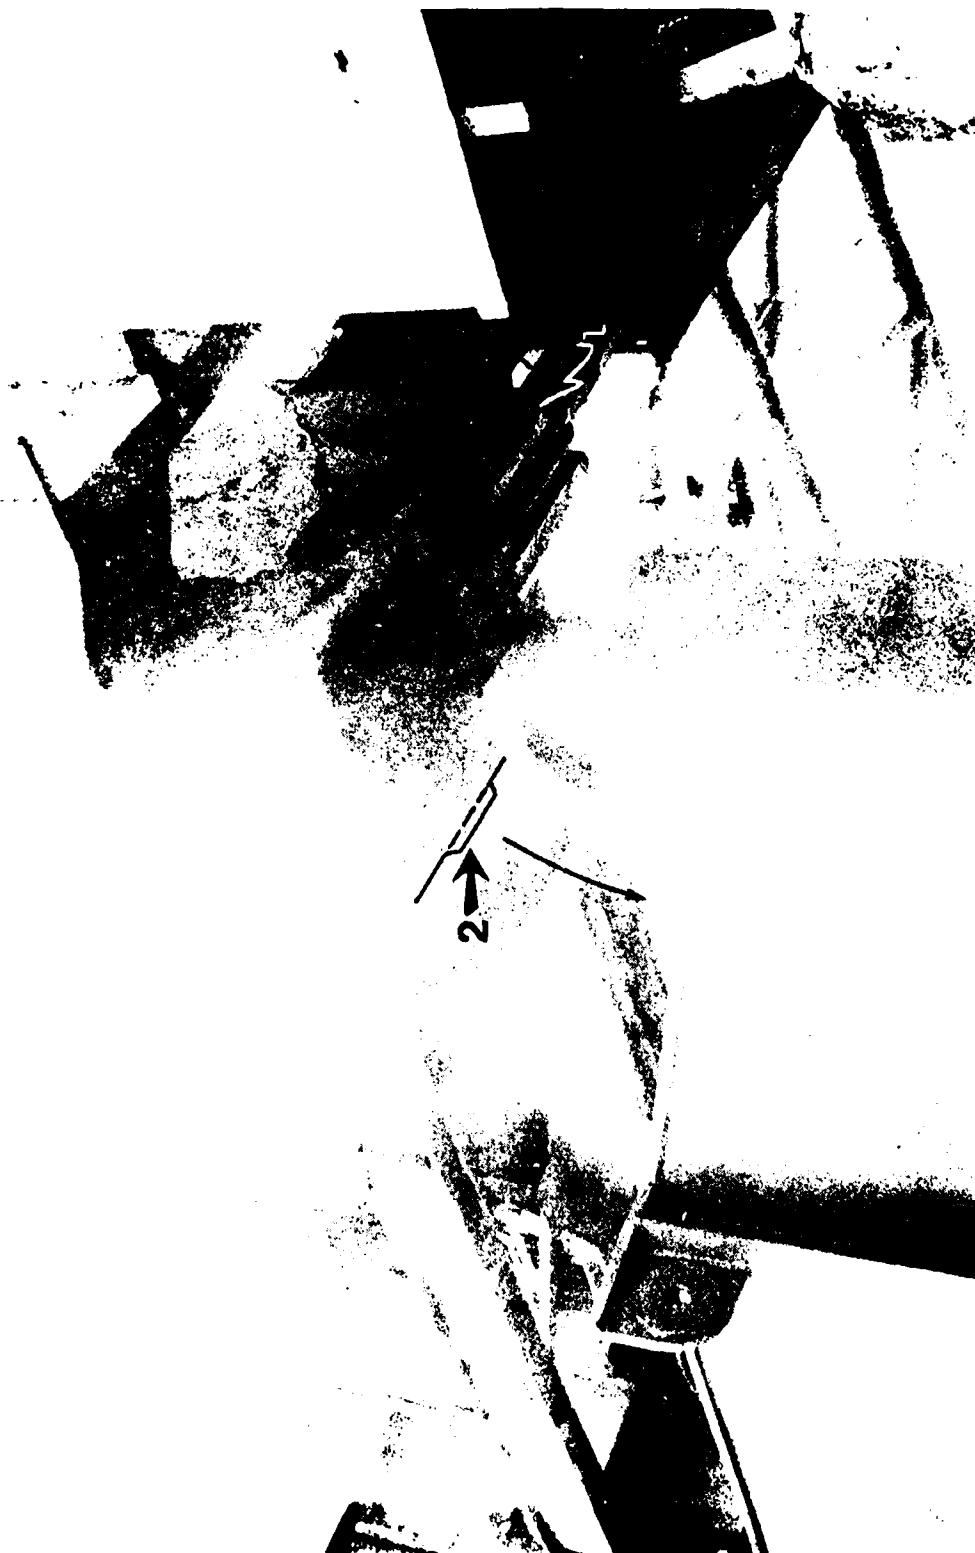
E.10. CRANE ATTEMPTS TO ENGAGE LCM8 LIFT BEAM. Gathering cones on the lighter gantry crane attempted to engage the LCM8 lifting beam. The cones (port and starboard—starboard shown) could not be seated far enough down on the LCM8 lift beam attachment points for the locking bar (see arrow one) to engage. A lip on the cone (see arrow two) prevented the seating.

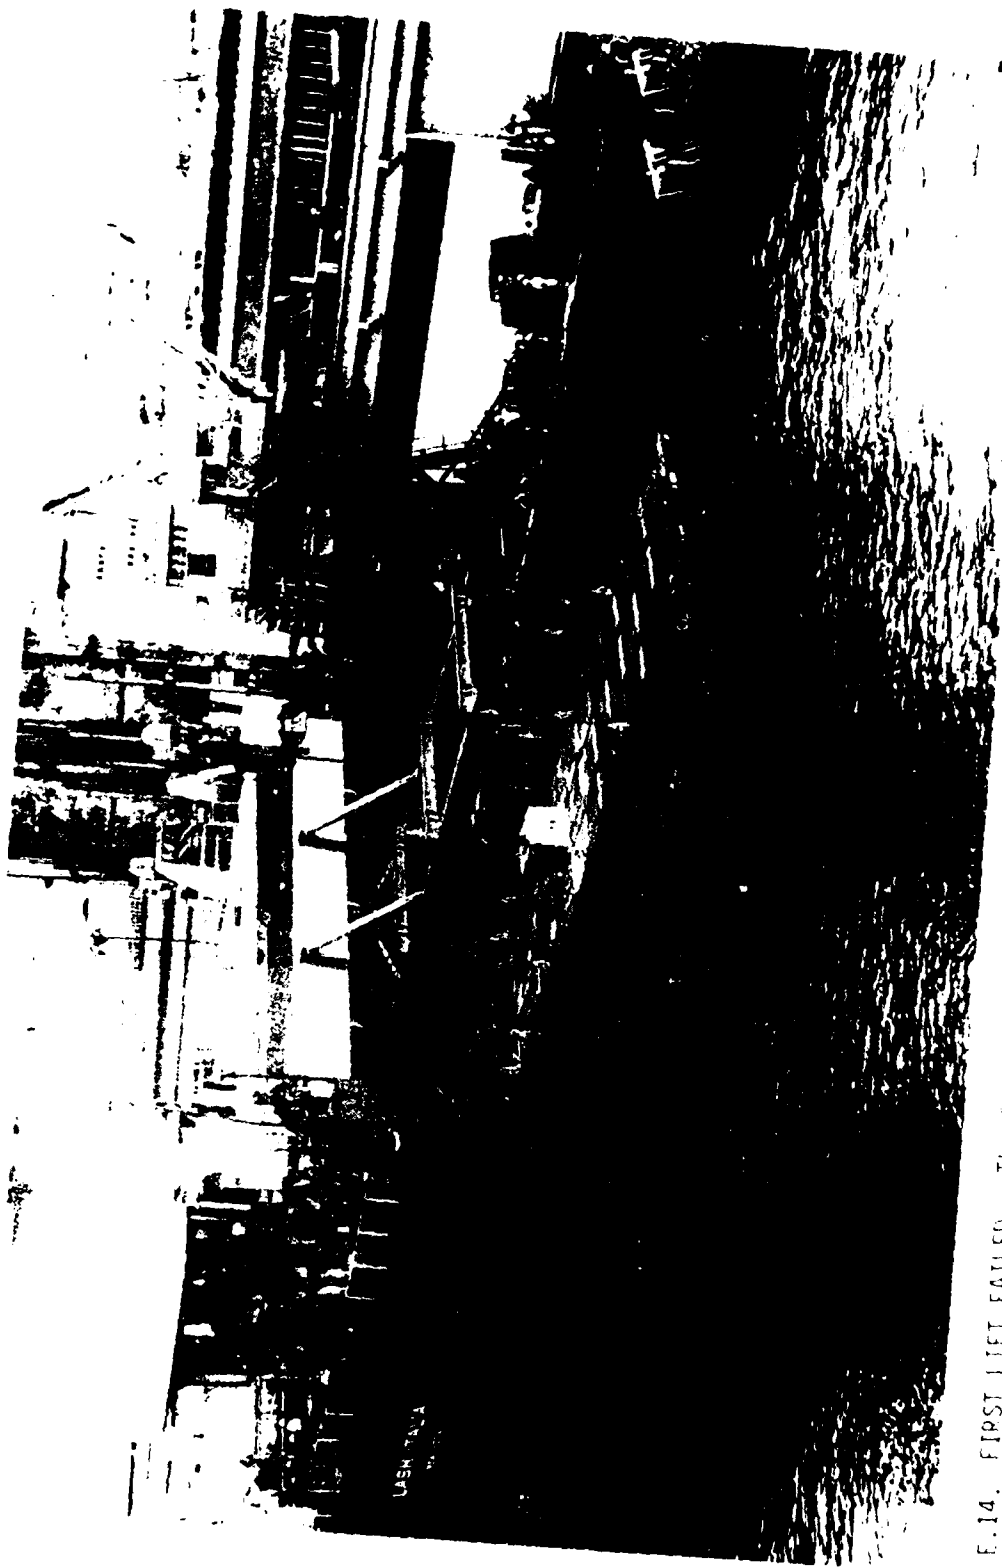
E.14. FIRST LIFT FAILED. The 3 x 25 causeway with 87.5 short tons aboard could not be safely hoisted by the lifting frame. In a second try, with a 7-ton block as shown, the 3 x 25 causeway was hoisted aboard ship. The American Bureau of Shipping was clipping for lifting roadway sections. The lift beam was then completed.

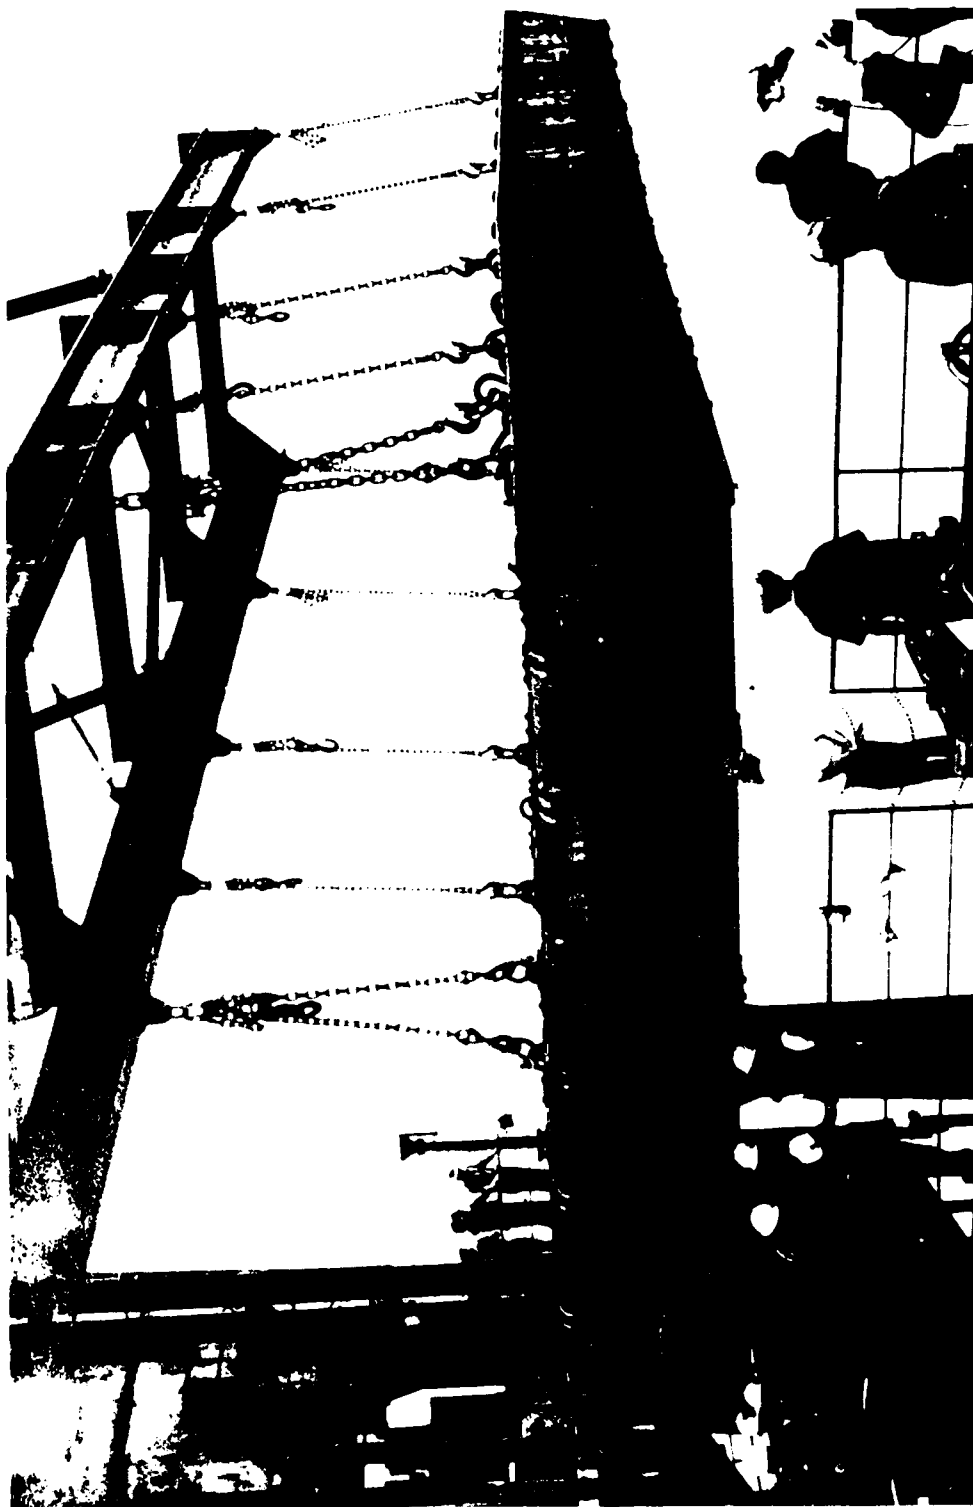
E.15. CAUSEWAY OFF-LOADING. Later, when the LASH ITALIA had been fully loaded, the ship moved to an anchorage off Green Beach, Ft. Story. After more than 7 hr spent trying to assemble the causeway lift frame to the LCM's lift beam, the 3 x 15 causeway was finally off-loaded in about 49 minutes. Disassembly of the device required about 80 minutes. A new method of attaching the causeway lift frame has subsequently been adopted.

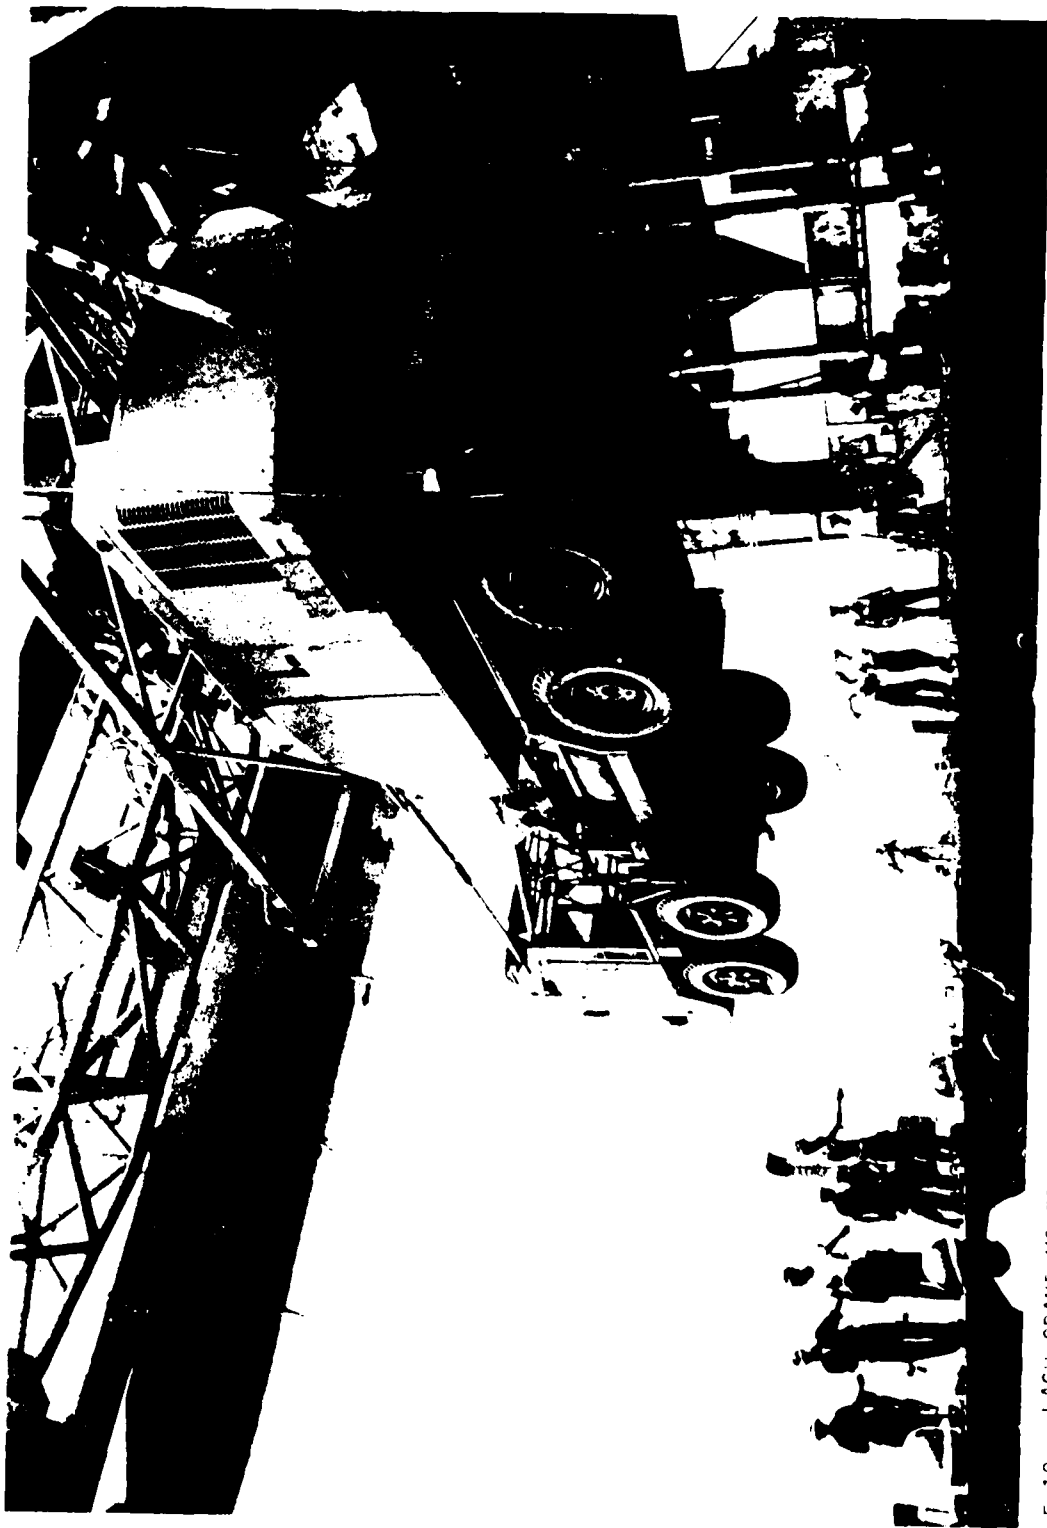
E.19. LASH CRANE MOVED SLOWLY. Once the LASH gantry crane had fully hoisted the Army's 140-ton crane, it moved slowly over the deck to limit pendulation. No direct action was encountered during the loading. The elapsed time for loading was 20 minutes for a 100-ton load with 1000.

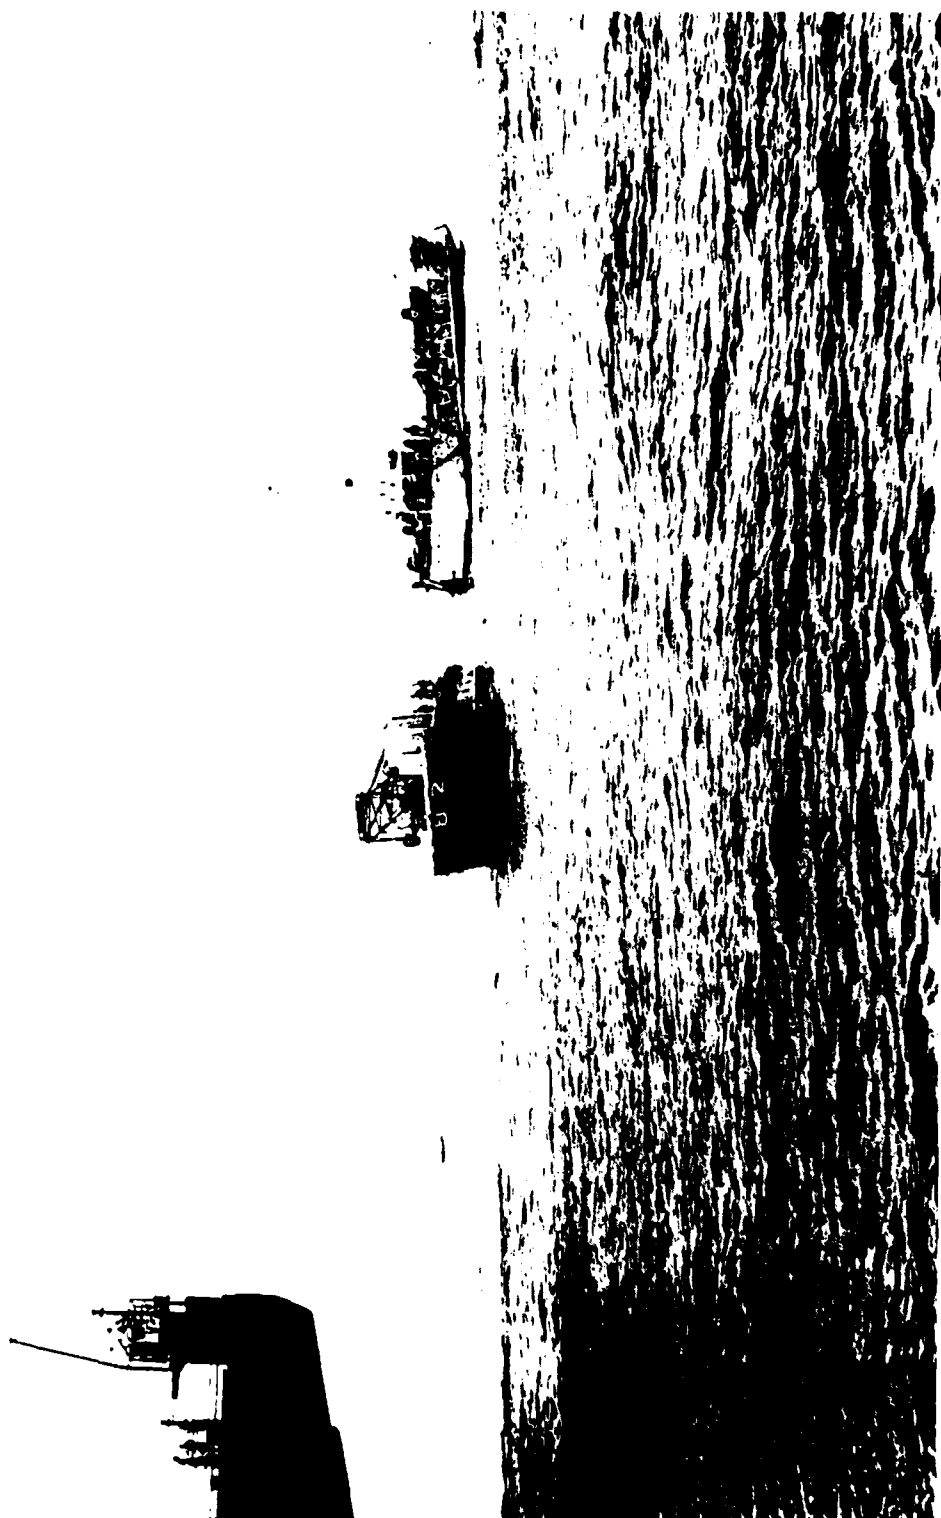
E.22. LCM8 WITH 140-TON CRANE CLEARS WELL. Once the sling was detached the LCM8 departed. Cycle time for the 140-ton crane off-load was 52 minutes.

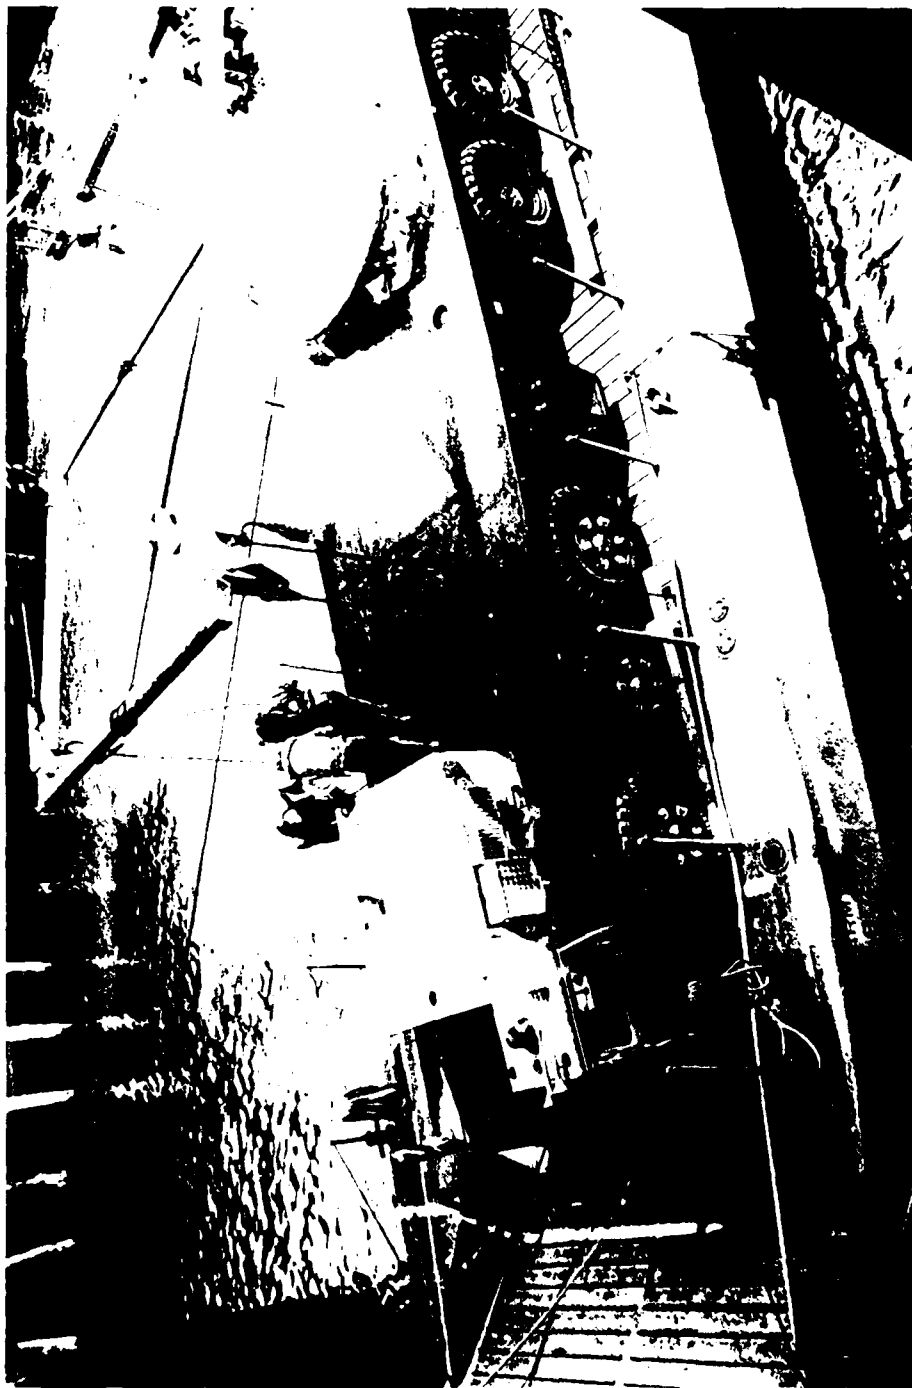
E-23. CARRIER FOR 300-TON CRANE READIED. The carrier for the Army's P&H 6250 crane (300-ton lifting capacity) was one of the selected items of LSTC equipment for the pretest. Because of its length (approximately 47 feet) and the fact that it required inclined wall deck ramps to be loaded and carried in an LCMs, the 6250 carrier was a priority item for testing.

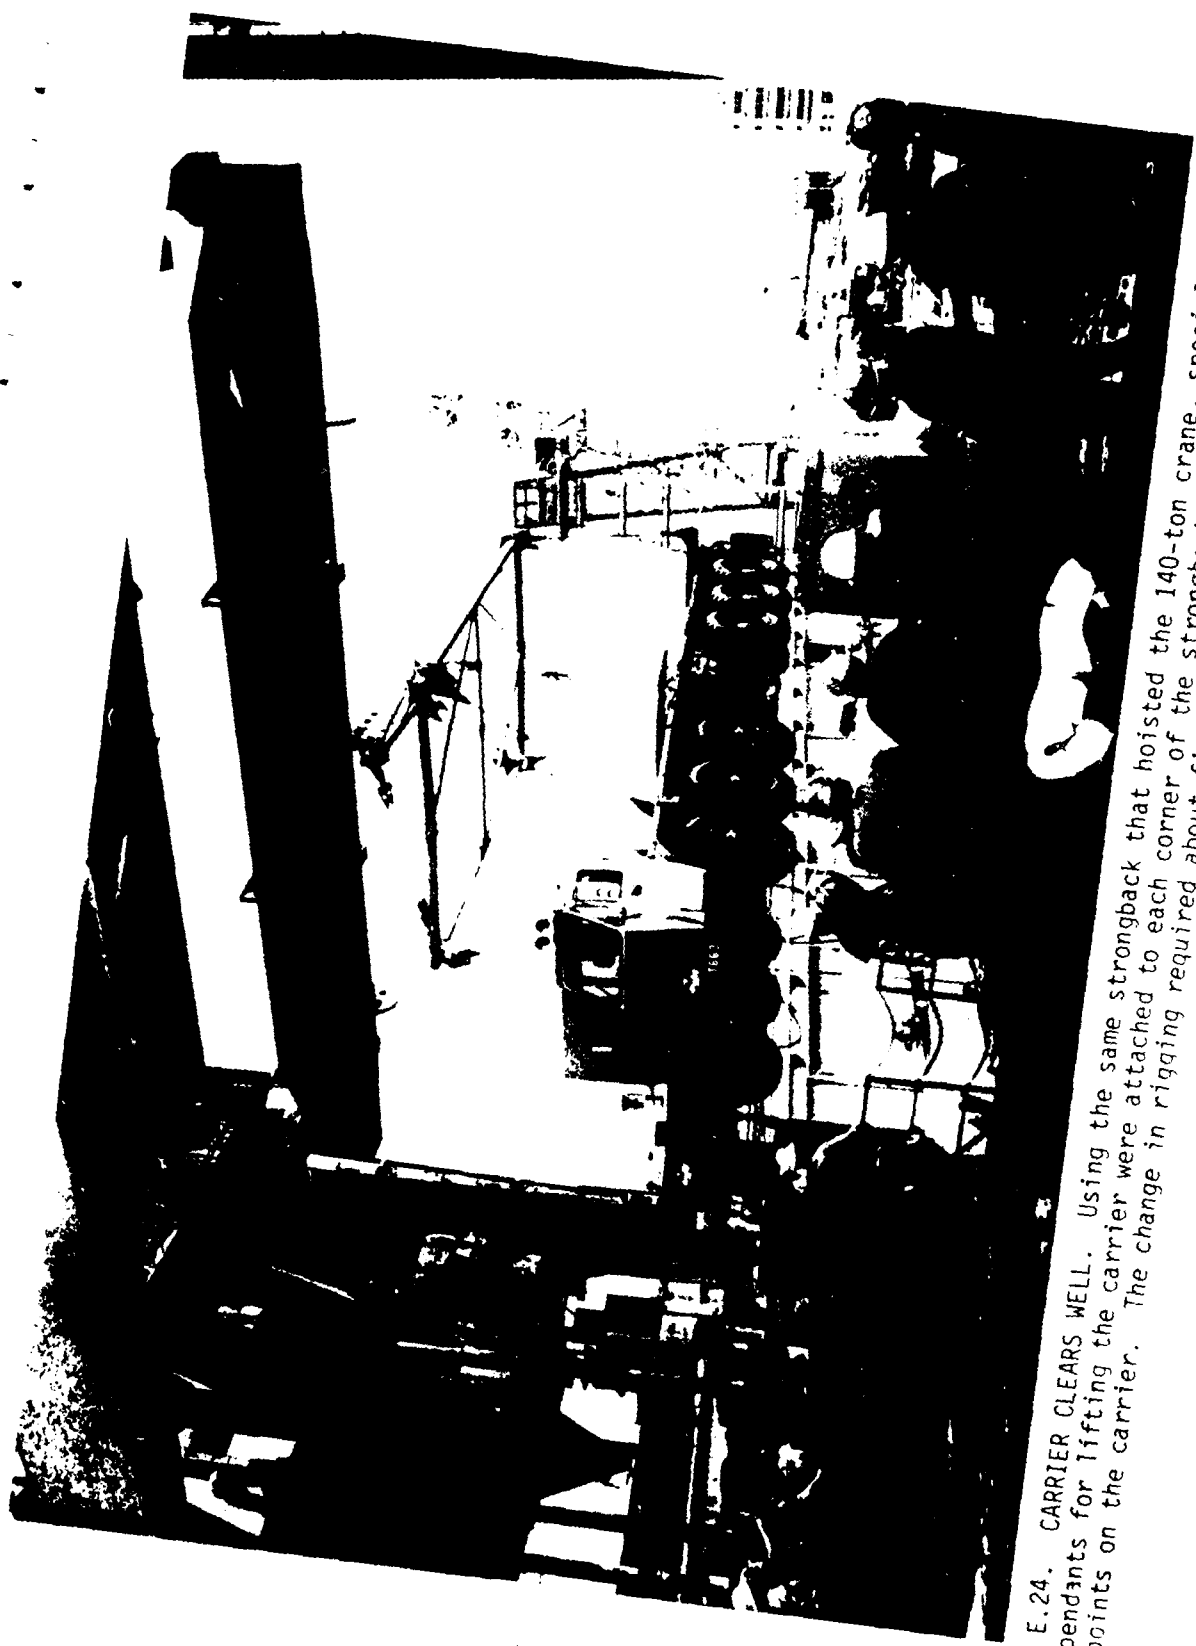
E.24. CARRIER CLEARS WELL. Using the same strongback that hoisted the 140-ton crane, special pendants for lifting the carrier were attached to each corner of the strongback and to special lifting points on the carrier. The change in rigging required about five minutes.

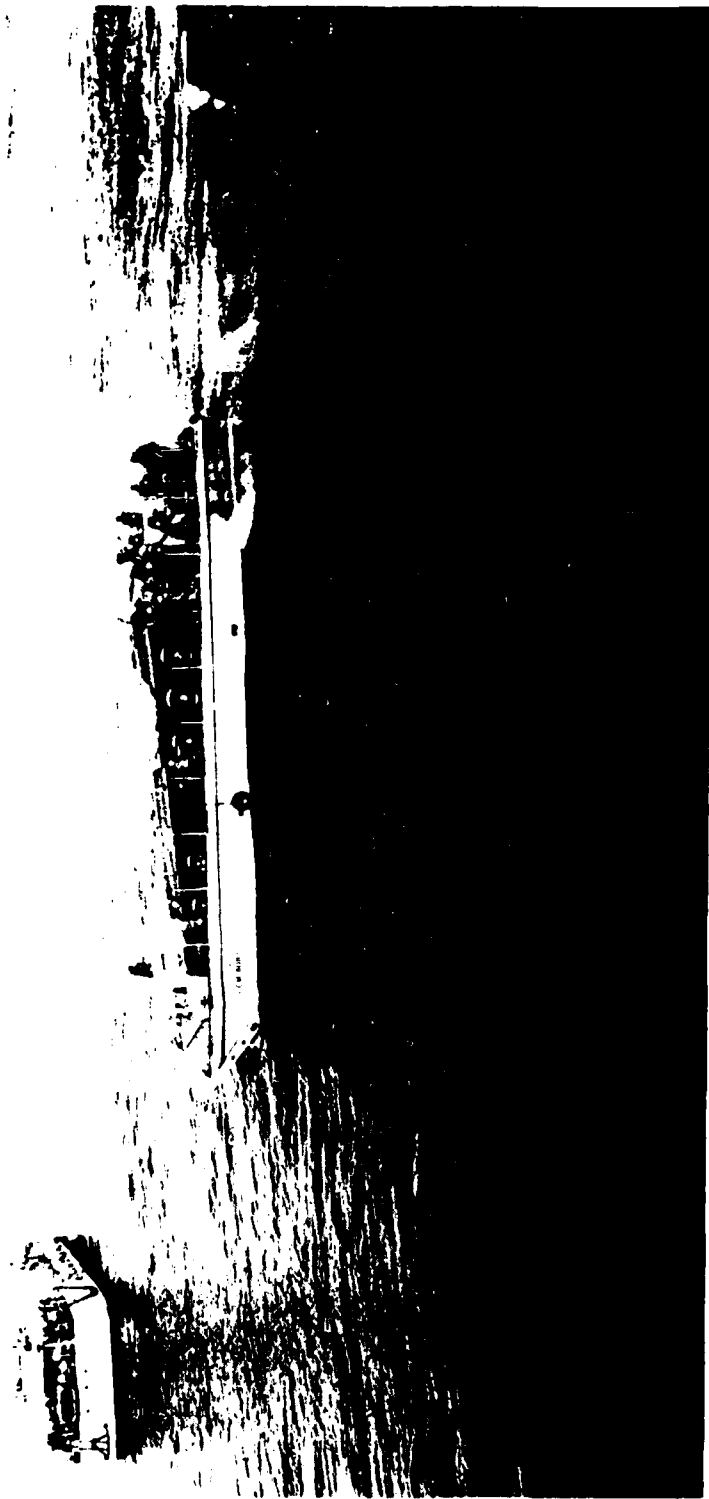
E.27. LCM8 WITH CARRIER UNDERWAY. Once the carrier had been off-loaded into the LCM8, it was necessary to start the carrier and back it approximately two feet up the well deck ramps to improve the trim of the LCM8 while underway. In the process of backing, the carrier got too far to the left side and the LCM8 took a slight port list.

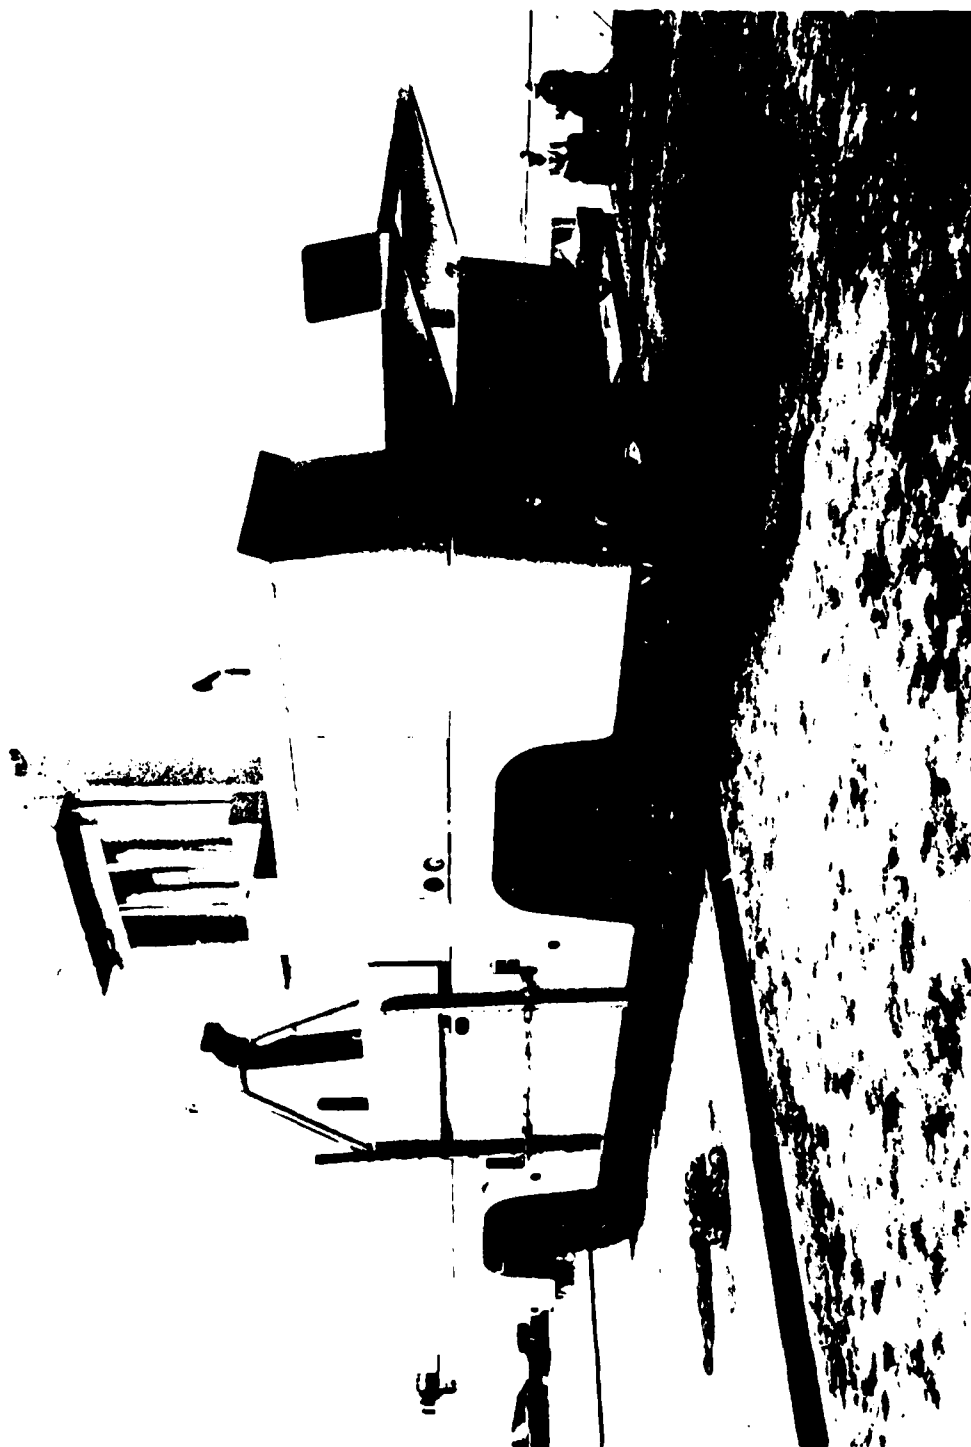
E.30. SIDELOADER REPOSITIONED ON DECK. During the off-loading phase the sideloader was driven to a position near the ship's centerline where rigging was being accomplished. The only disassembly of the sideloader for the pretest was the removal of the container spreader bar, which only slightly reduced the weight of the 70-short ton sideloader.
